# Manhole Inspection Summary

Manhole # S29K\_\_033MH

Insp Date: **11/5/08 9:28 AM**

**Location** Address: **638 S Fremont Ave**

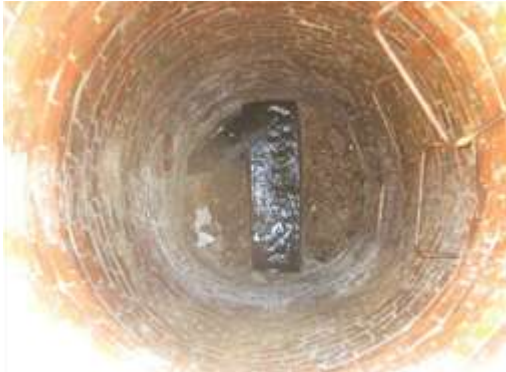
Defect 2

Condition: ☐ Sound ☐ Cracked ☐ Root Intrusion ☐ Deteriorated ☐ Leaks ☒ **Debris**

Bench Debris

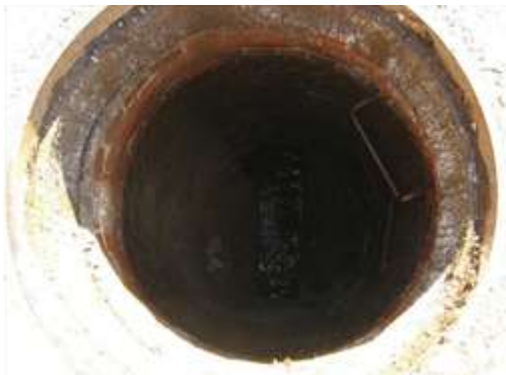
### Defect 1

Offset: **2** (in.)

☒ **Leaks**

frame offset, leaks

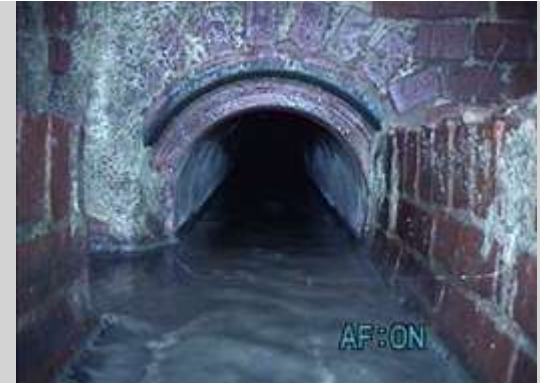
12 O'Clock Outflow

15 in. Circular Gravity Sewer  
Pipe Out @ 12 O'Clock

Pipe Height: **14.4** (in.) Rod and Bar (Angled)  
Pipe Material: **Clay** ☐ Pipe Lined  
Invert Depth: **12.36** (ft.) Flow Characteristics: **Fast**  
Deposits: ☒ None ☐ Mud ☐ Sludge ☐ Debris ☐ Grease  
Silt Depth: **0** (in.) Deposits Extent:  
Infiltration: **None** Pipe Seal Cond: **Sound**

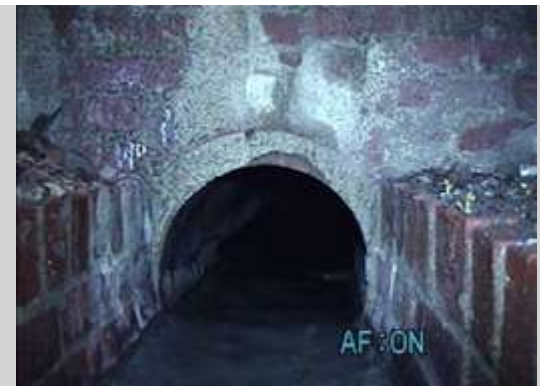
6 O'Clock Inflow

15 in. Circular Gravity Sewer  
Pipe In @ 6 O'Clock

Pipe Height: **14.4** (in.) Rod and Bar (Angled)  
Pipe Material: **Clay** ☐ Pipe Lined  
Invert Depth: **12.34** (ft.) Flow Characteristics: **Fast**  
Deposits: ☒ None ☐ Mud ☐ Sludge ☐ Debris ☐ Grease  
Silt Depth: **0** (in.) Deposits Extent:  
Infiltration: **None** Pipe Seal Cond: **Sound**

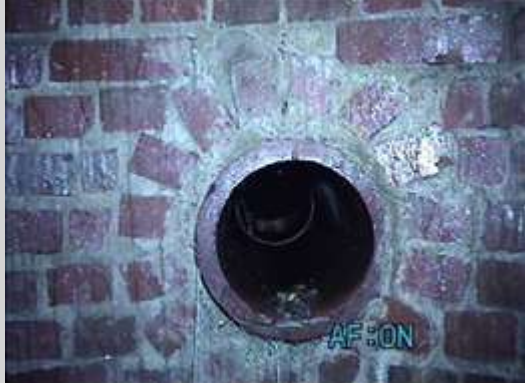
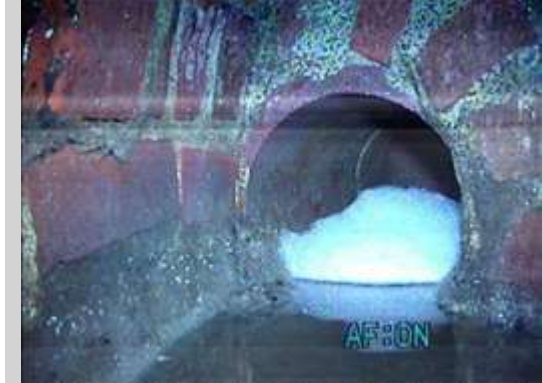
9 O'Clock Inflow

8 in. Circular Gravity Sewer

Pipe In @ 9 O'Clock

Drop In @ 9 O'Clock

Pipe Height: **8.4** (in.) Rod and Bar (Angled)

Drop: **Inside**

Drop Condition: **Open**
